**Flood Control Project Maintenance
Levee Inspections**

Maintenance Issue Types Only, Levee Inspection Report By Mile - Spring 2019

Reclamation District No. 2089 Stark

Waterway	Bank	Unit Miles	Inspection Start/End	Inspector
Unit No. 01 Old River	Right	1.51	04/04/2019 04/04/2019	Alberto De Leon

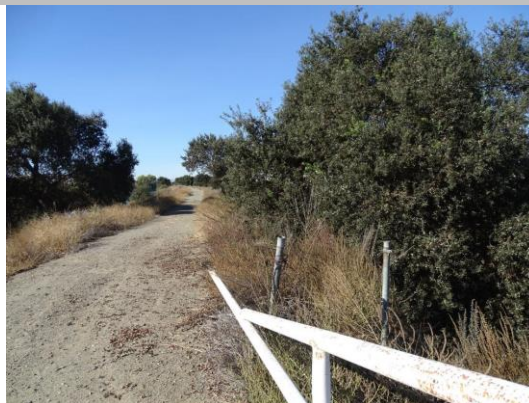
Photo 1 of 2 : SP_2019_RD2089_316_24_20190313_00025.jpg

LM Start	0.00	Rating **	U	Issue No.	24
LM End	0.77	Issue Type +	Ma	Location *	LS
Category	Earthen Levee			GPS Latitude/Longitude	
				Start	End
Item	Vegetation			37.811547 °	37.808843 °
				-121.385268 °	-121.397613 °
DWR ID	DWR_RD2089_01_f_2018_24				
Comment Code					
V1 : Control annual grass and weeds on the levee slopes and easements.					
Inspector Comment

Typical view of landward slope. (Fall 2018)

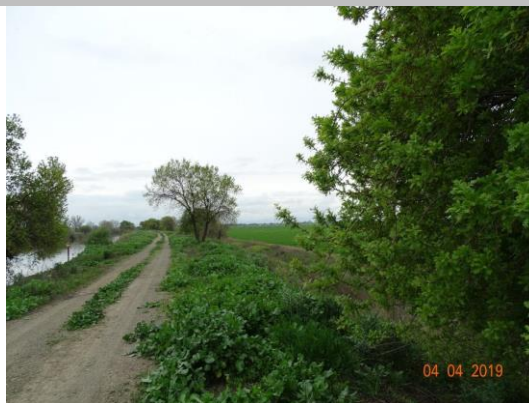
Photo 2 of 2 : SP_2019_RD2089_316_24_20190422_00056.jpg

Typical view of vegetation on landside slope. (Spring 2019)

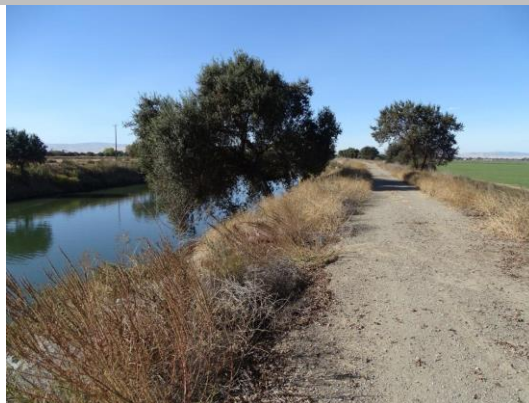
Photo 1 of 2 : SP_2019_RD2089_316_16_20190313_00014.jpg

LM Start	0.02	Rating **	U	Issue No.	16
LM End	1.51	Issue Type +	Ma	Location *	WS
Category	Earthen Levee			GPS Latitude/Longitude	
				Start	End
Item	Vegetation			37.811547 °	37.806633 °
				-121.385268 °	-121.407885 °
DWR ID	DWR_RD2089_01_f_2018_16				
Comment Code					
V1 : Control annual grass and weeds on the levee slopes and easements.					
Inspector Comment

Looking at typical view of waterward slope. (Fall 2018)

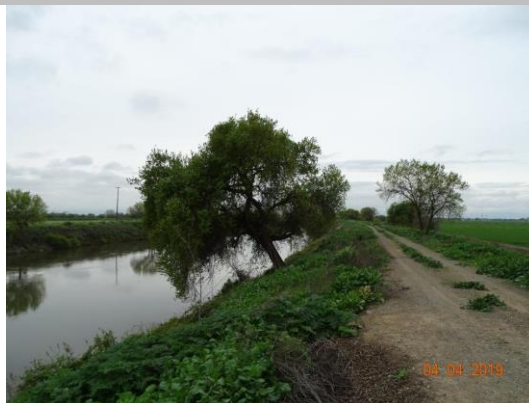
Photo 2 of 2 : SP_2019_RD2089_316_16_20190422_00055.jpg

Typical view of vegetation on waterside slope. (Spring 2019)

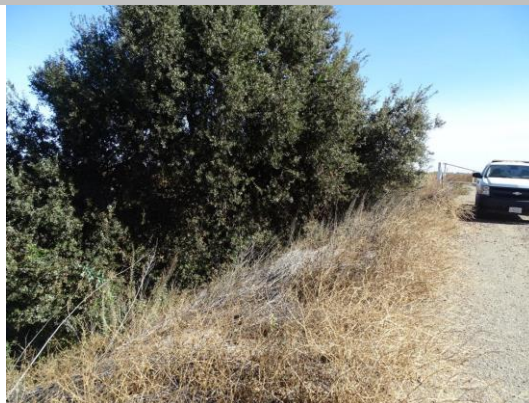
Photo 1 of 1 : SP_2019_RD2089_316_18_20190313_00017.jpg

Looking west at untrimmed trees on landward slope. (Fall 2018)

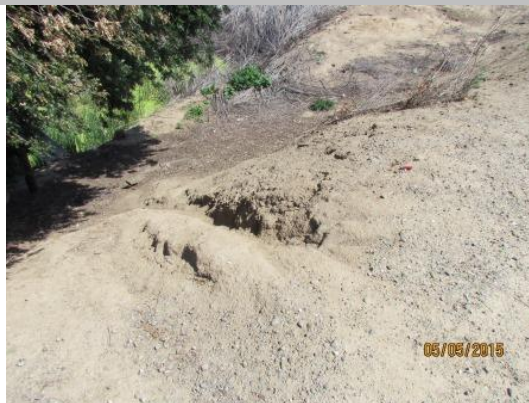
Photo 1 of 2 : SP_2019_RD2089_316_1_20190313_00001.jpg

View of the stairs eroding into the landside levee slope.

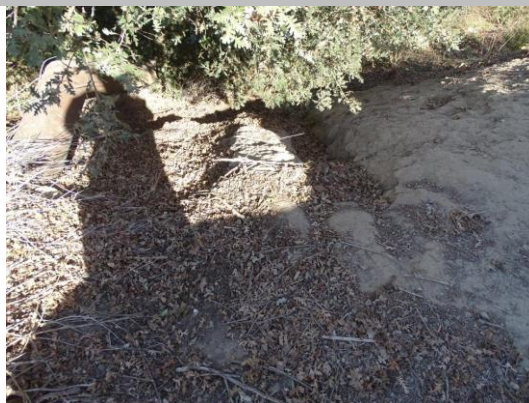
Photo 2 of 2 : SP_2019_RD2089_316_1_20190313_00002.jpg

View of the stairs eroding into the landside levee slope. (Fall 2018)

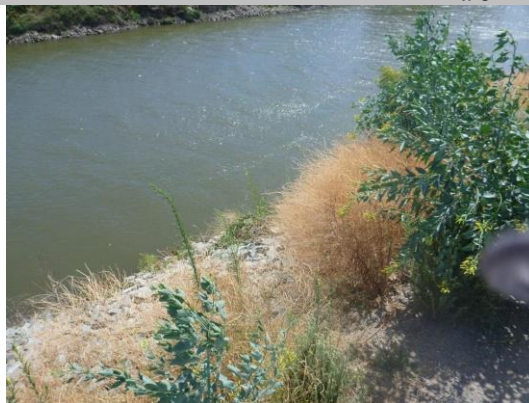
Photo 2 of 2 : LEVAL_SP_2019_513_4448.jpg

LM Start	0.26	Rating **	M	Issue No.	13 (cont)	
LM End	0.27	Issue Type +	Ma	Location *		
Category	Supplemental			GPS Latitude/Longitude		
				Start	End	
Item	2017 Storm Damage			37.810300 °	37.810300 °	
				-121.389300 °	-121.389500 °	
DWR ID	DWR_RD2089_01_f_2017_13					
Comment Code						
Inspector Comment						
Levee Evaluation Comments						
Description:Slope protection repairs are needed along the waterside slope due to erosion and riprap displacement from high water. Based upon levee inspections, it was determined the waterside levee slope is eroding, deteriorating, and degrading. The eroded levee sections need to be restored back to design standards to prevent further deterioration and damage.						
Site ID No:513						
Site Designation:LMA-419						
Repair Type: Erosion						
Rating:Area of Concern						
Field Date:8/14/2017						
Notes: Small erosion at toe.

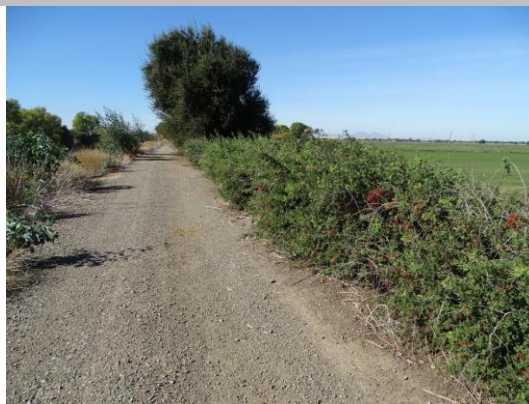
Photo 1 of 1 : SP_2019_RD2089_316_23_20190313_00024.jpg

LM Start	0.30	Rating **	U	Issue No.	23
LM End	0.32	Issue Type +	Ma	Location *	LS
Category	Earthen Levee			GPS Latitude/Longitude	
				Start	End
Item	Vegetation			37.810138 °	37.810043 °
				-121.390020 °	-121.390343 °
DWR ID	DWR_RD2089_01_f_2018_23				
Comment Code					
V2 : Remove the wild growth other than native grasses from the levee slopes.					
Inspector Comment					
Berryvines and wild roses on landward shoulder and slope blocking view.

Looking at dense berryvines and wild roses on landward shoulder and slope. (Fall 2018)

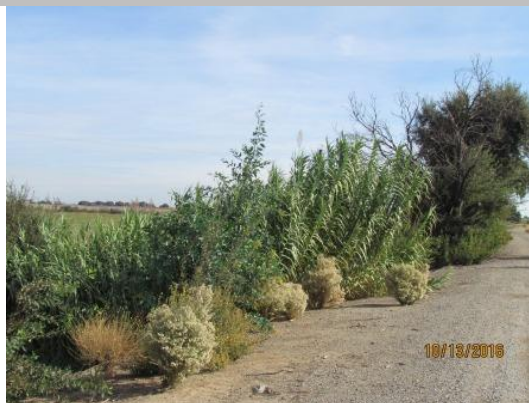
Photo 1 of 2 : SP_2019_RD2089_316_19_20190313_00018.jpg

View of the arundo back on the landside levee slope. Fall 2016

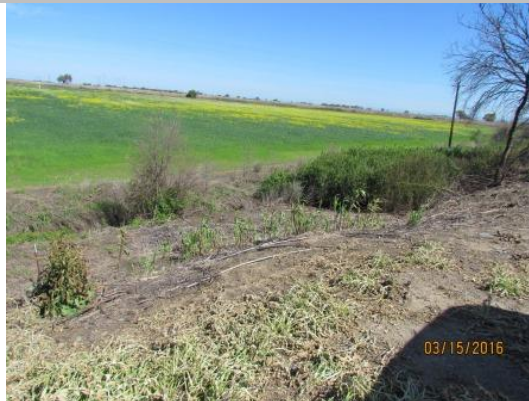
Photo 2 of 2 : SP_2019_RD2089_316_19_20190313_00019.jpg

View of trimmed arundo. Spring 2016

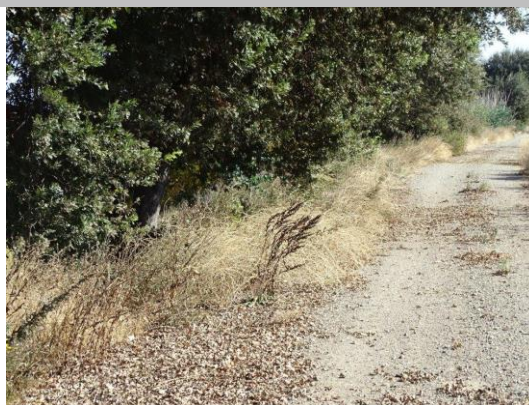
Photo 2 of 2 : SP_2019_RD2089_316_28_20190313_00028.jpg

Looking at dense veg on landward slope. (Fall 2018)

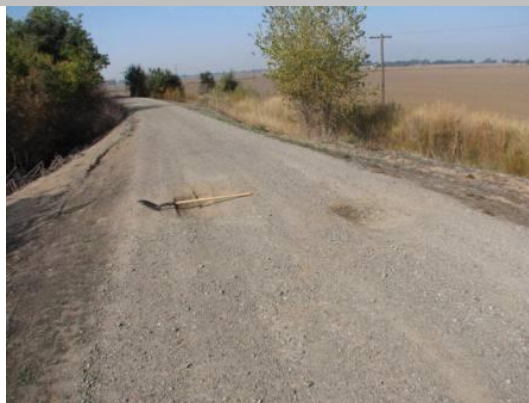
Photo 1 of 1 : SP_2019_RD2089_316_14_20190313_00013.jpg

LM Start	0.54	Rating **	M	Issue No.	14
LM End	0.54	Issue Type +	Ma	Location *	CR
Category	Earthen Levee			GPS Latitude/Longitude	
				Start	End
Item	Crown Surface / Depressions / Rutting			37.810087 °	37.810087 °
				-121.394200 °	-121.394200 °
DWR ID	DWR_RD2089_01_s_2012_14				
Comment Code					
C3 : Add appropriate gravel or road base. Grade and compact.					
Inspector Comment					
Minor depressions will cause ponding.

11/10/2011 Depressions in crown.

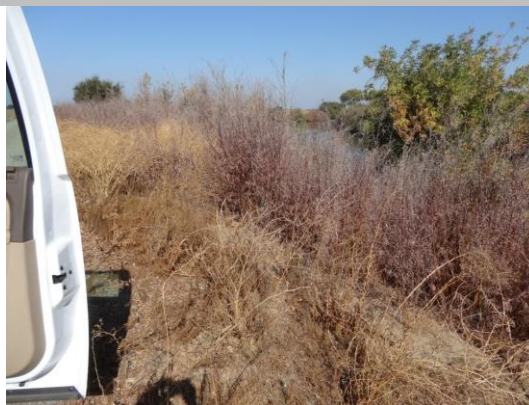
Photo 2 of 2 : SP_2019_RD2089_316_5_20190313_00009.jpg

Comment Code					
Inspector Comment					
09/13/2017: No significant change observed.					
07/25/2016: No significant change observed.					
06/25/2015: No significant change observed.					
07/02/2014: No significant change observed.					
08/13/2013: No significant change observed.					
08/07/2012: The site has been visited by boat survey. No significant change observed					
08/23/2011: The 5-foot vertical scarp shows no significant change from the last year inspection. No new erosion activities observed. Dense white willow trees on site.					
09/07/2010: It was difficult to view the erosion due to the thick Willow thickets and other vegetation at the water line. At the time of the inspection, there were no signs of repair on site. As noted during the last survey, there is a 5-foot vertical scarp along the lower slope that may be subjected to high flow velocities.					
08/05/2010: Recommended for repair, per CLRO; "Erosion of this site may be subjective to rapid rates of erosion."

09/28/2009: No major change observed; 5-foot vertical scarp is immediately downstream of where berm has tapered; site is recommended as local maintenance issue, per CLRO CES Evaluation 2008 Report; Site # is the same as RM29.6, LM0.60; previously rated "U".					
11/05/2008: No change observed; rodent holes on lower slope; wide levee crown. [2017 Site ID:RD2089U01RM29.61]

Front view of the site. Note the very dense white willow thickets on site.

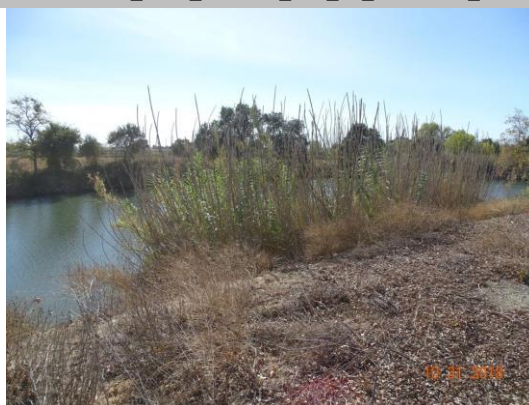
Photo 1 of 2 : SP_2019_RD2089_316_33_20190313_00032.jpg

Re-establishing of Arundo on waterward slope. (Fall 2018)

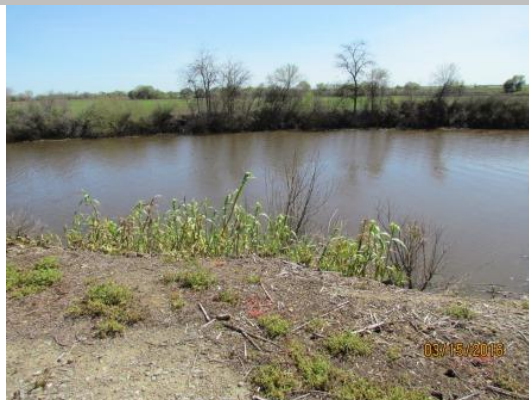
Photo 2 of 2 : SP_2019_RD2089_316_33_20190313_00033.jpg

View of when Arundo was trimmed back. Spring 2016

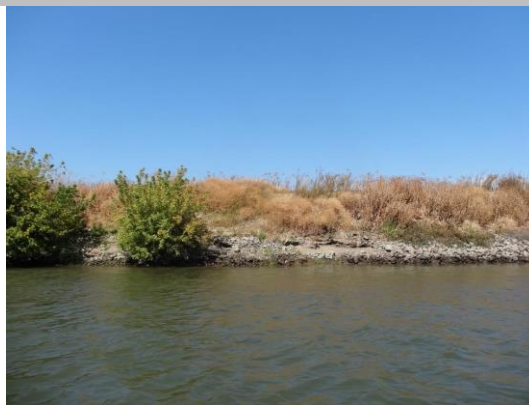
Photo 3 of 3 : SP_2019_RD2089_316_3_20190313_00007.jpg

Front view of the erosion.

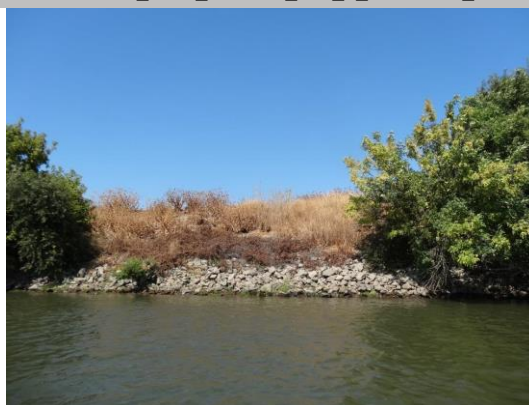
Photo 1 of 2 : SP_2019_RD2089_316_2_20190313_00003.jpg

LM Start	1.23	Rating **	M	Issue No.	2
LM End	1.24	Issue Type +	Ma	Location *	WS
Category	Supplemental			GPS Latitude/Longitude	
				Start	End
Item	DWR Erosion Survey			37.805580 °	37.805580 °
				-121.403010 °	-121.403010 °
DWR ID	RD2089U01RM29.04				
Comment Code					
Inspector Comment					
09/13/2017: No significant change observed. More vegetation observed at the site.					
09/16/2016: The river was not navigable near the site due to the dense water grass, so the site was visited by land survey. No significant change observed.					
06/25/2015: No significant change observed.					
07/02/2014: No significant change observed.					
08/13/2013: The erosion is around a tree at the levee toe. Dense vegetation is visible. [2017 Site ID:RD2089U01RM29.04]

Front view of the erosion.

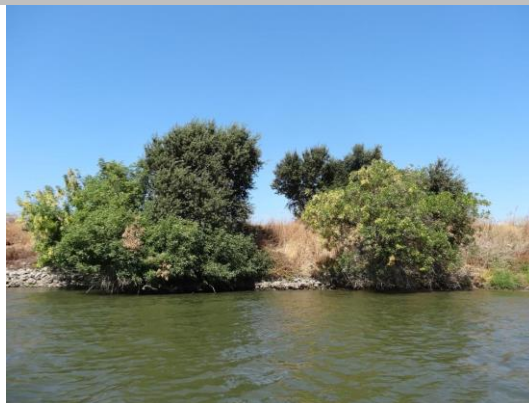
Photo 2 of 2 : SP_2019_RD2089_316_2_20190313_00004.jpg

Close view of the erosion.

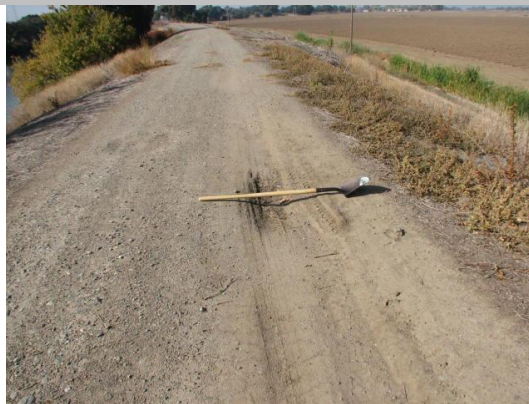
Photo 1 of 1 : SP_2019_RD2089_316_44_20190313_00035.jpg

View of roadway depression. 11/10/2011

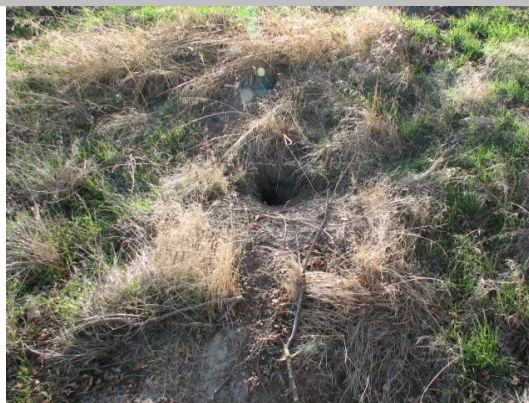
Photo 1 of 1 : SP_2019_RD2089_316_47_20190313_00037.jpg

View of active rodent burrow on landside slope. 11/10/2011

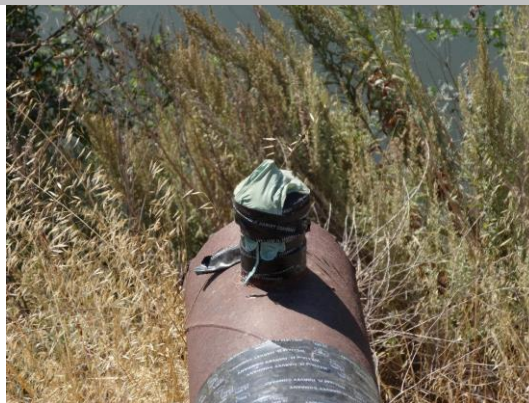
Photo 2 of 3 : UCIP_SP_2019_21585_36623.jpg

LM Start	1.41	Rating **	M	Issue No.	944
LM End	1.41	Issue Type +	Ma	Location *	
Category	Supplemental			GPS Latitude/Longitude	
				Start	End
Item	DWR UCIP LMA Responsibility			37.806323 °	37.806323 °
				-121.406155 °	-121.406155 °
DWR ID	23045				
Comment Code					
Inspector Comment					
FS_ID:21585 DS_ID:23045 EP_NO: N/A Repair Type: Non-Urgent Crossing Status: Found UCIP Comments: - siphon breaker needs repair. FIELD_STRUCT_DESC: 10-inch steel drainage discharge pipe through the levee, 2.4 feet below the crown. Pump in a drainage ditch on the landside (LS). Siphon breaker on the waterside (WS) shoulder. [Additional Reference(s): DWR Levee Log, 1991]. FS Date: 9/12/2013

WS view: exposed steel pipe with siphon breaker. Looks siphon breaker needs repair.

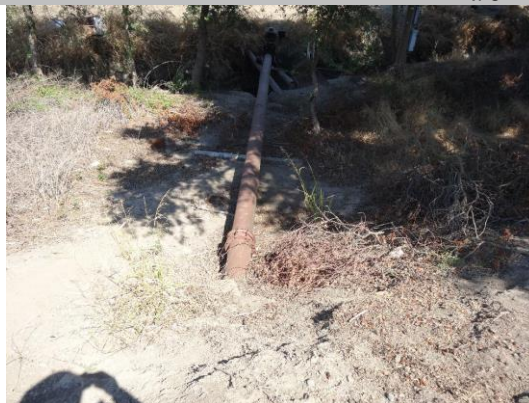
Photo 3 of 3 : UCIP_SP_2019_21585_36622.jpg

LS view: exposed steel pipe on levee slope.

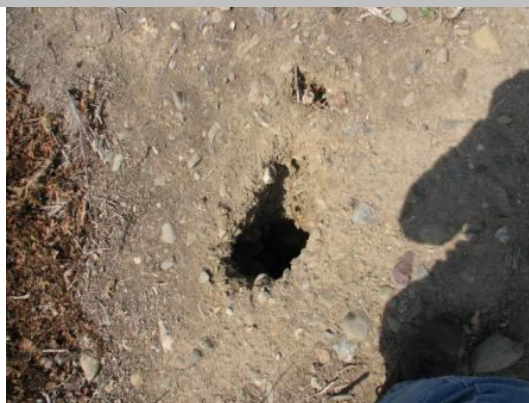
Photo 1 of 1 : SP_2019_RD2089_316_49_20190313_00038.jpg

View of deep burrow on waterside. 11/10/2011

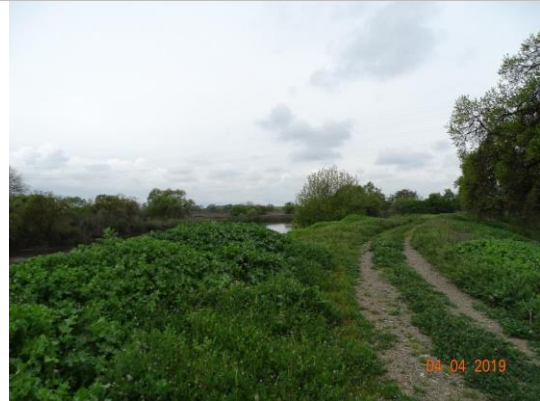
Photo 1 of 1 : SP_2019_RD2089_317_58_20190422_00070.jpg

Typical view of vegetation on waterside slope. (Spring 2019)

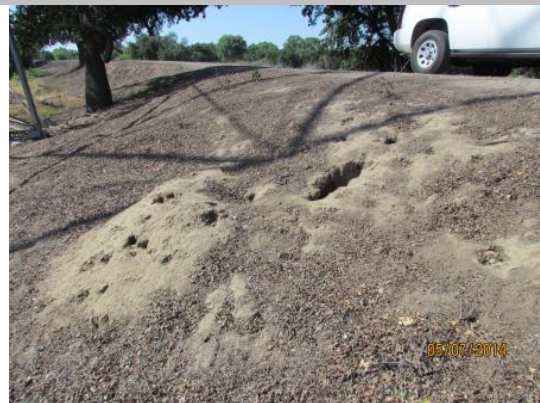
Photo 1 of 1 : SP_2019_RD2089_317_48_20190313_00049.jpg

View of the rodent burrow on the landside levee slope.

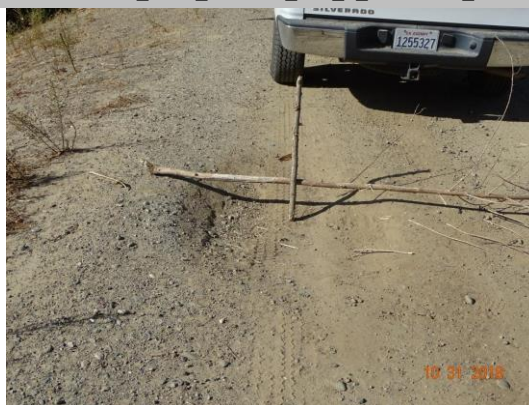
Photo 1 of 1 : SP_2019_RD2089_317_7_20190313_00007.jpg

View of depression greater that six inches on levee crown. (Fall 2018)

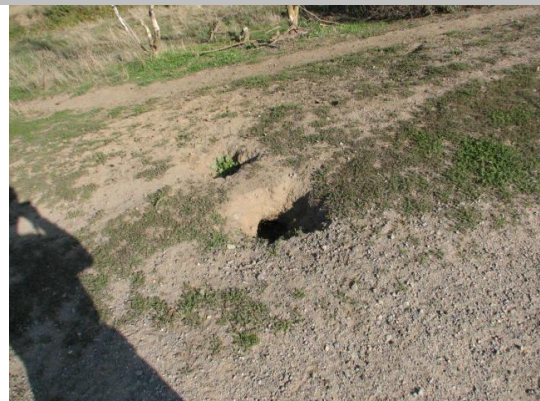
Photo 1 of 1 : SP_2019_RD2089_317_13_20190313_00015.jpg

View of two large burrows on crown, need to be filled. 11/10/2011

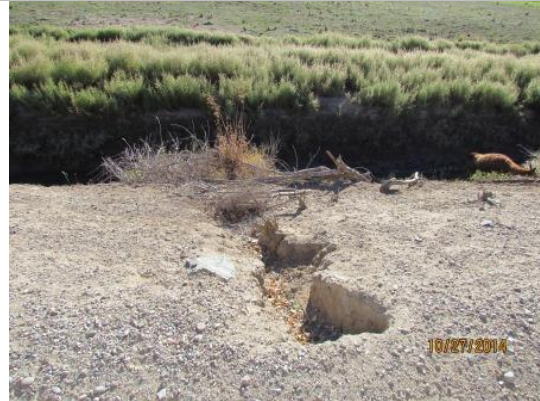
Photo 1 of 1 : SP_2019_RD2089_317_15_20190313_00017.jpg

View of the scour from surface runoff on the landside levee slope.

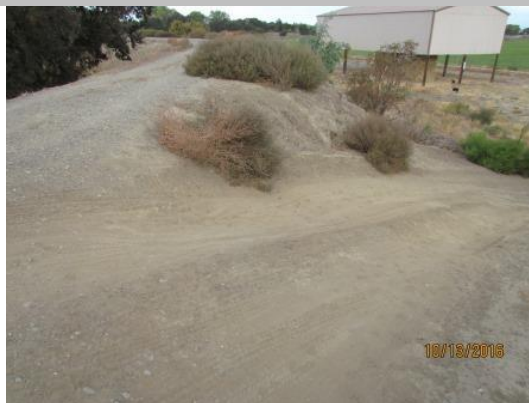
Photo 1 of 1 : SP_2019_RD2089_317_42_20190313_00042.jpg

View of the ramp on the landside levee slope.

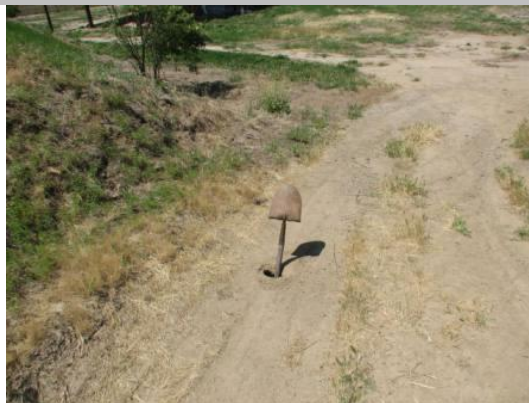
Photo 1 of 3 : SP_2019_RD2089_317_40_20190313_00038.jpg

View of deep vertical burrow in ramp on landside of levee. 05/24/2011

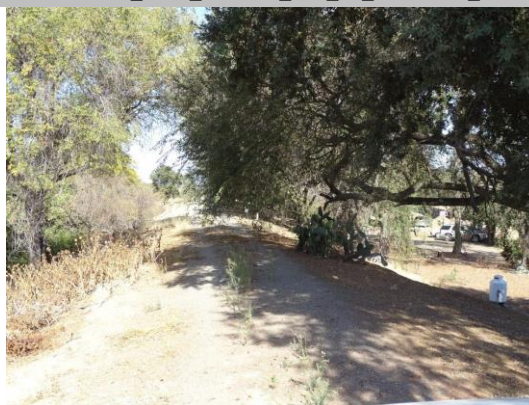
Photo 1 of 1 : SP_2019_RD2089_317_33_20190313_00032.jpg

Looking west at trees overhanging crown of levee. (Fall 2018)

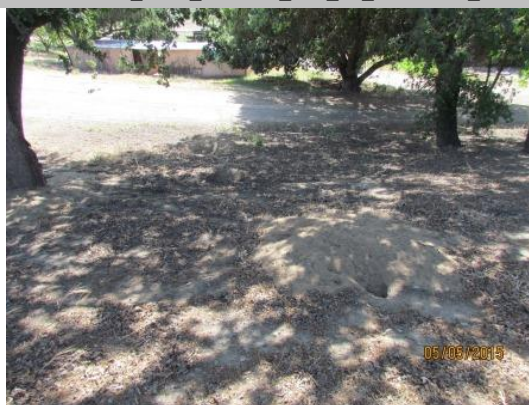
Photo 1 of 1 : SP_2019_RD2089_317_11_20190313_00012.jpg

View of the multiple rodent burrows on the landside levee slope.
